Torque Tube Pins - options for improvement

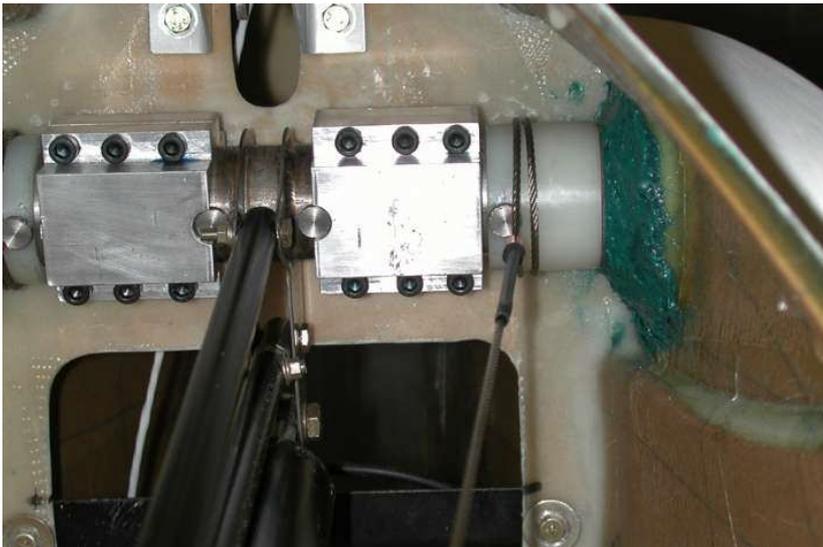
Option 5 PFA Mod 10623 (Bob Harrison's mod)

This option involved bolting split blocks between the TP9 and TP12 fittings see picture below

The main criticism of this mod are:-

- a) The limited grip the blocks have on the edges of the TP9 and TP12 components.
- b) Weight
- c) Cost £190 + VAT and intends to raise price on any new orders.
